# Home Inspection Report

Address Redacted

Report Prepared By:  
James H. Duke

July 24, 2006

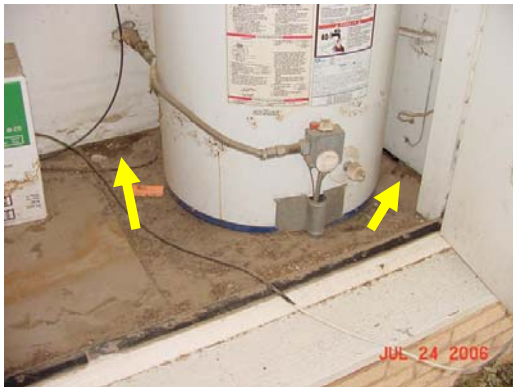
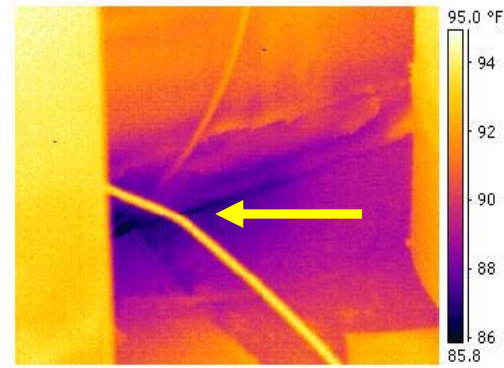
- B. There is the possibility for a mold issue inside the mechanical closet on the west side of the home. The floor in the mechanical closet is collapsing from moisture damage (a leaking water heater). Recommend destructive testing by a mold remediation company and remedy as appropriate. See photos 3 and 4 for damage.

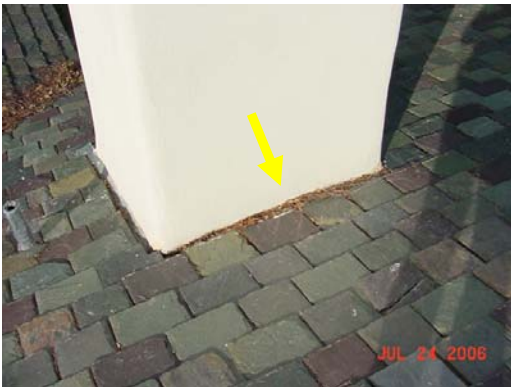
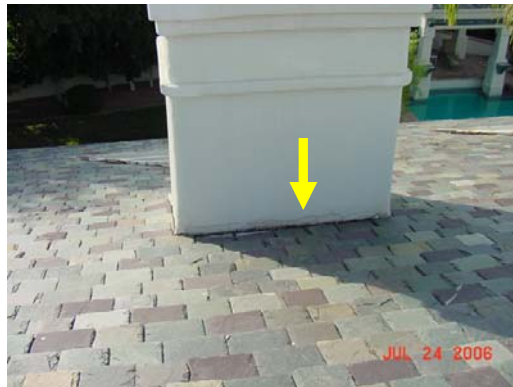
- A. There is no saddle flashing (cricket) on any of the fireplace chimneys. Crickets are required when the width of the chimney exceeds 30-inches. Recommend installation of proper crickets by a licensed roofing contractor. Also recommend through inspection of chimney flashing as damage was detected in ceilings below some of the fireplaces. See photos 20 through 22 for detail.

All the chimneys are more than 30 inches wide and do not have crickets as required. This condition traps debris and contributes to roof leakage. Recommend repair as appropriate.
