# Home Inspection Report

Address Redacted

Report Prepared By:  
James H. Duke

July 24, 2006

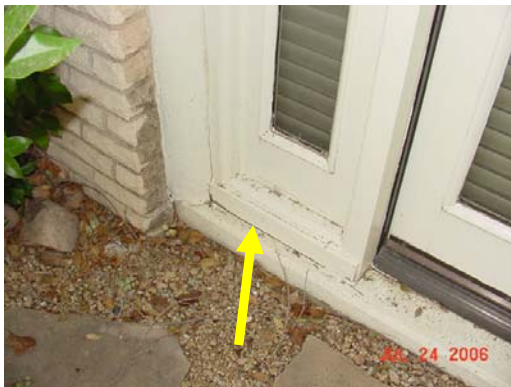
Photo #14

- C. There is moisture damaged wood at several of the exit door frames and several of the doors exhibit moisture damage at the glue joints. Recommend replacement of affected components. See photos 14 through 17 for examples.
- D. The column on the covered ramada at the east side of the pool has damage to the southwest pillar. Recommend evaluation and repair by a licensed siding contractor. Damage might be due to a leak associated with the water feature for the pool. See photo 18 for detail.
- E. The service door from the garage to the exterior could not be tested for function due to stored items against the door. Recommend testing door once items are removed. See photo 19 for detail.
